METEOROID AND DEBRIS IMPACT FEATURES DOCUMENTED ON THE LONG DURATION EXPOSURE FACILITY

A Preliminary Report

Compiled by Members
of the LDEF Meteoroid
and Debris Special
Investigation Group

Space & Life Sciences Directorate
Solar System Exploration Division
Planetary Science Branch
Publication # 84
JSC # 24608

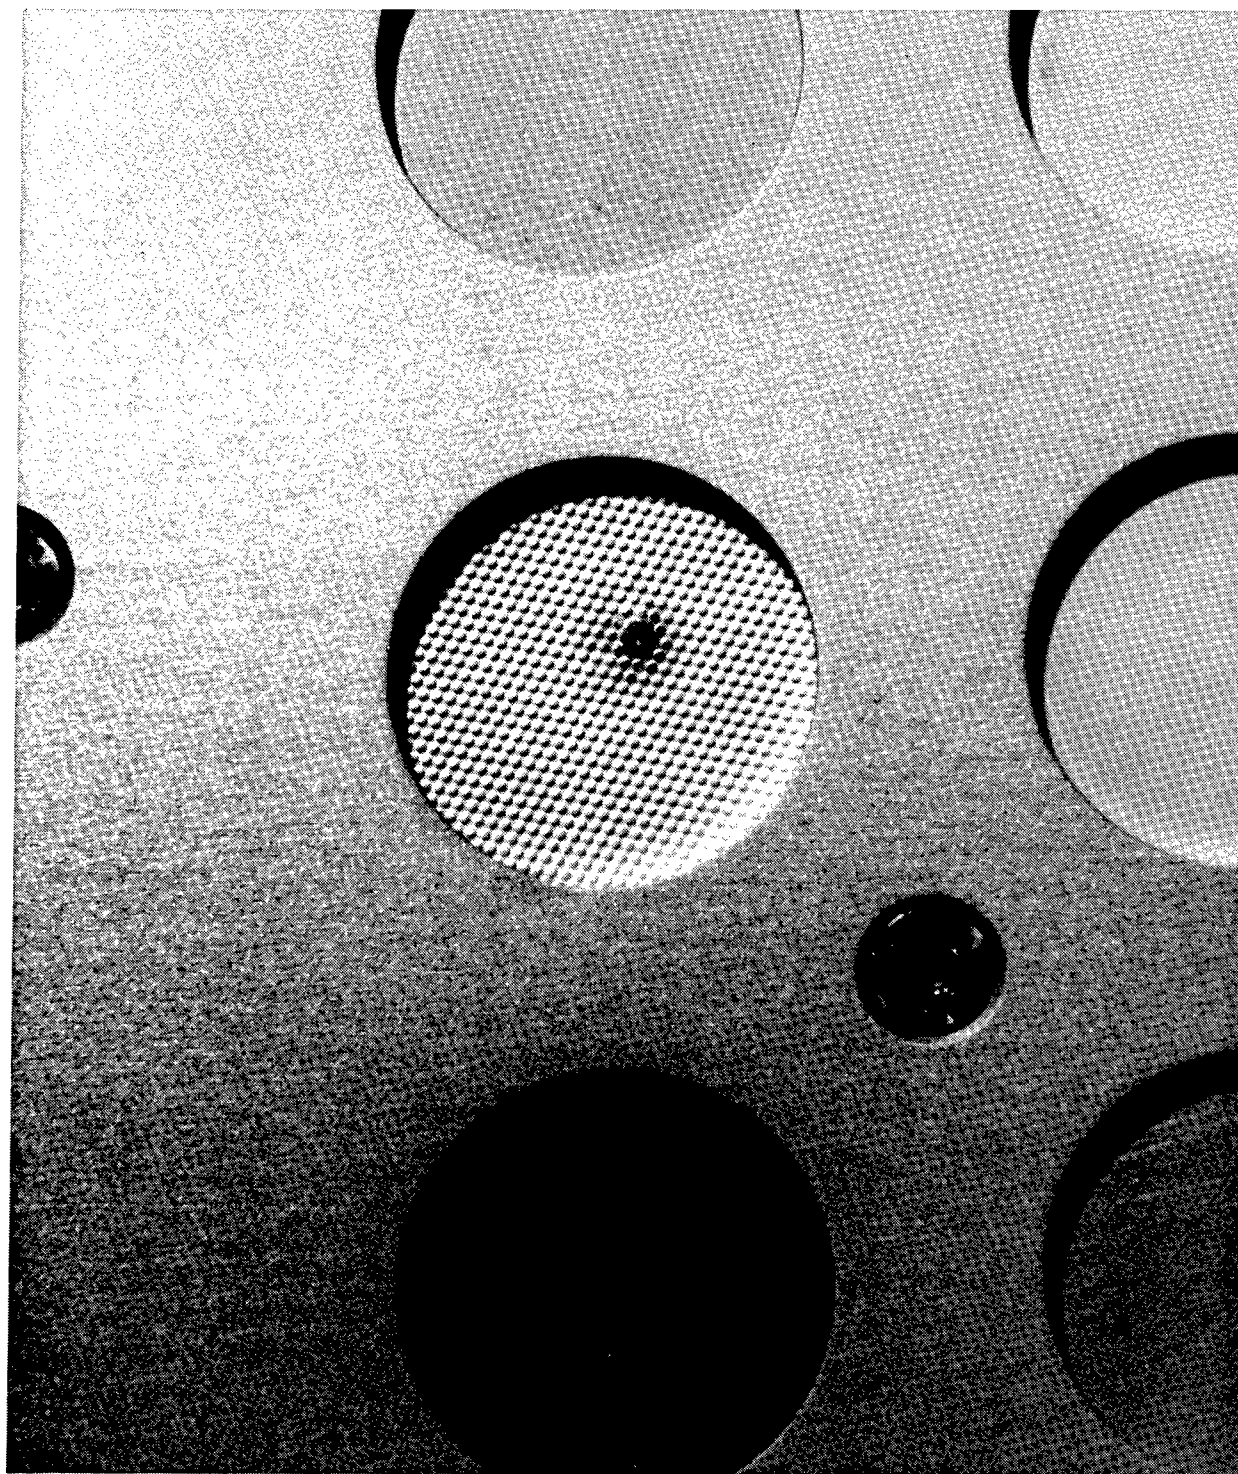
Figure B09-3. This view illustrates impact features in two materials from the bottom of Tray B09. View measures approximately 4 cm across.

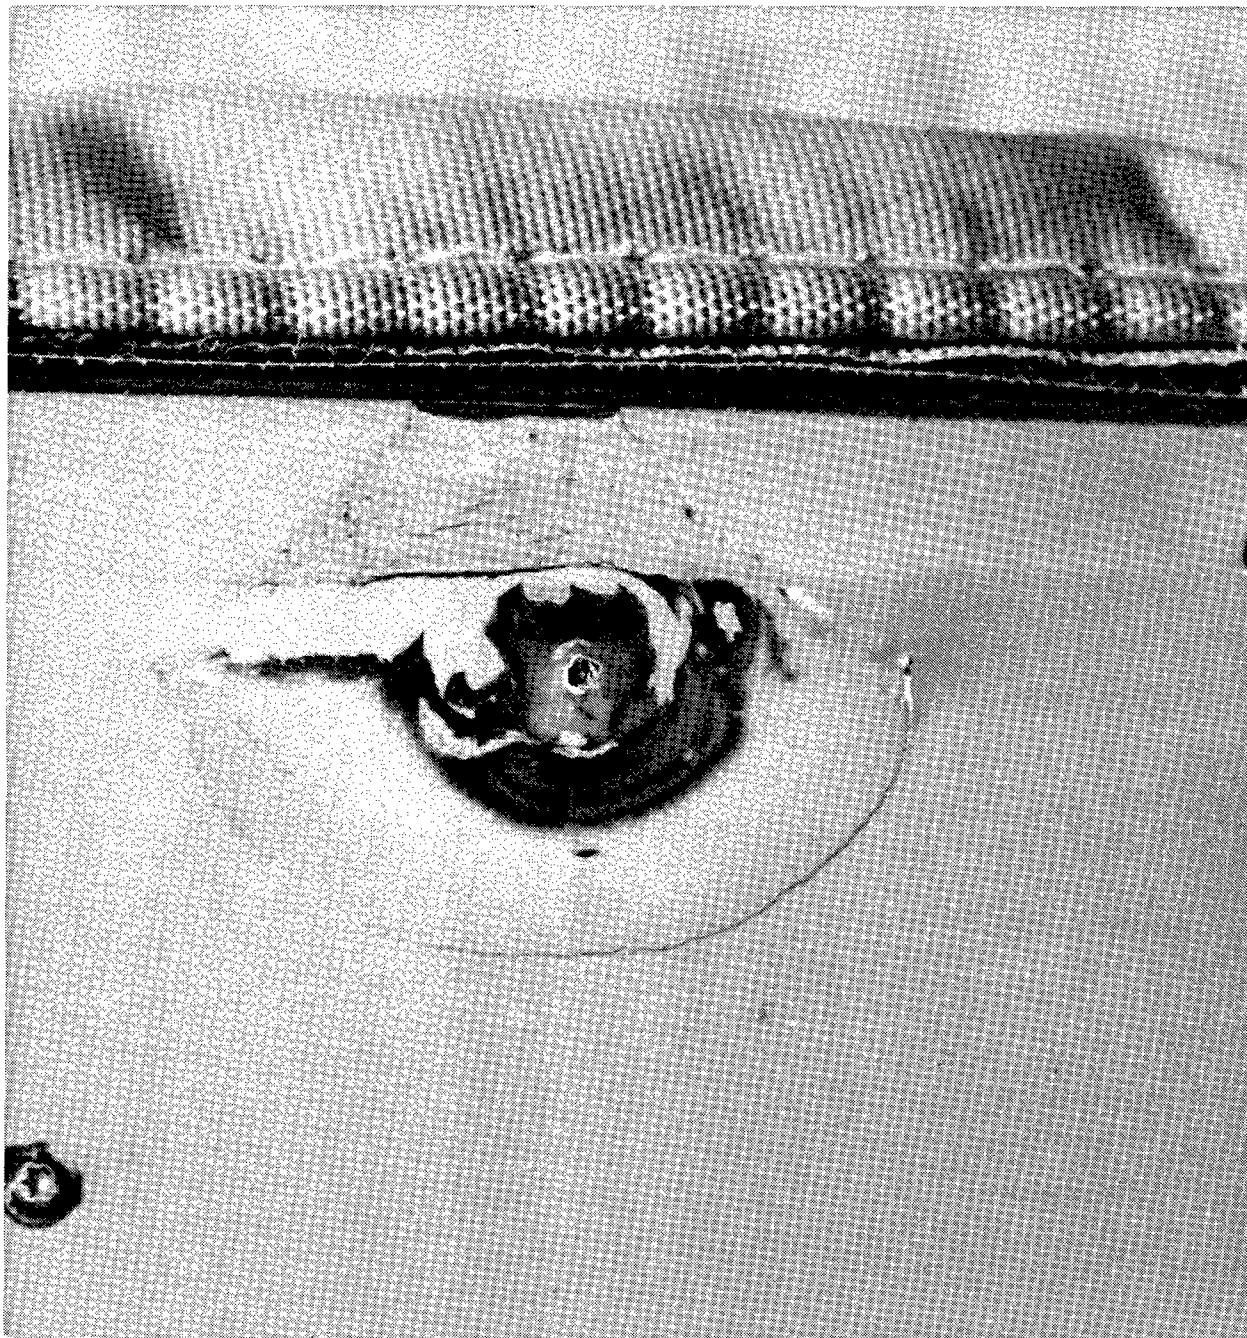
Figure B10-2. This is a view of a large impact with spall across one of the heat-pipe covers. View measures approximately 4 cm across.

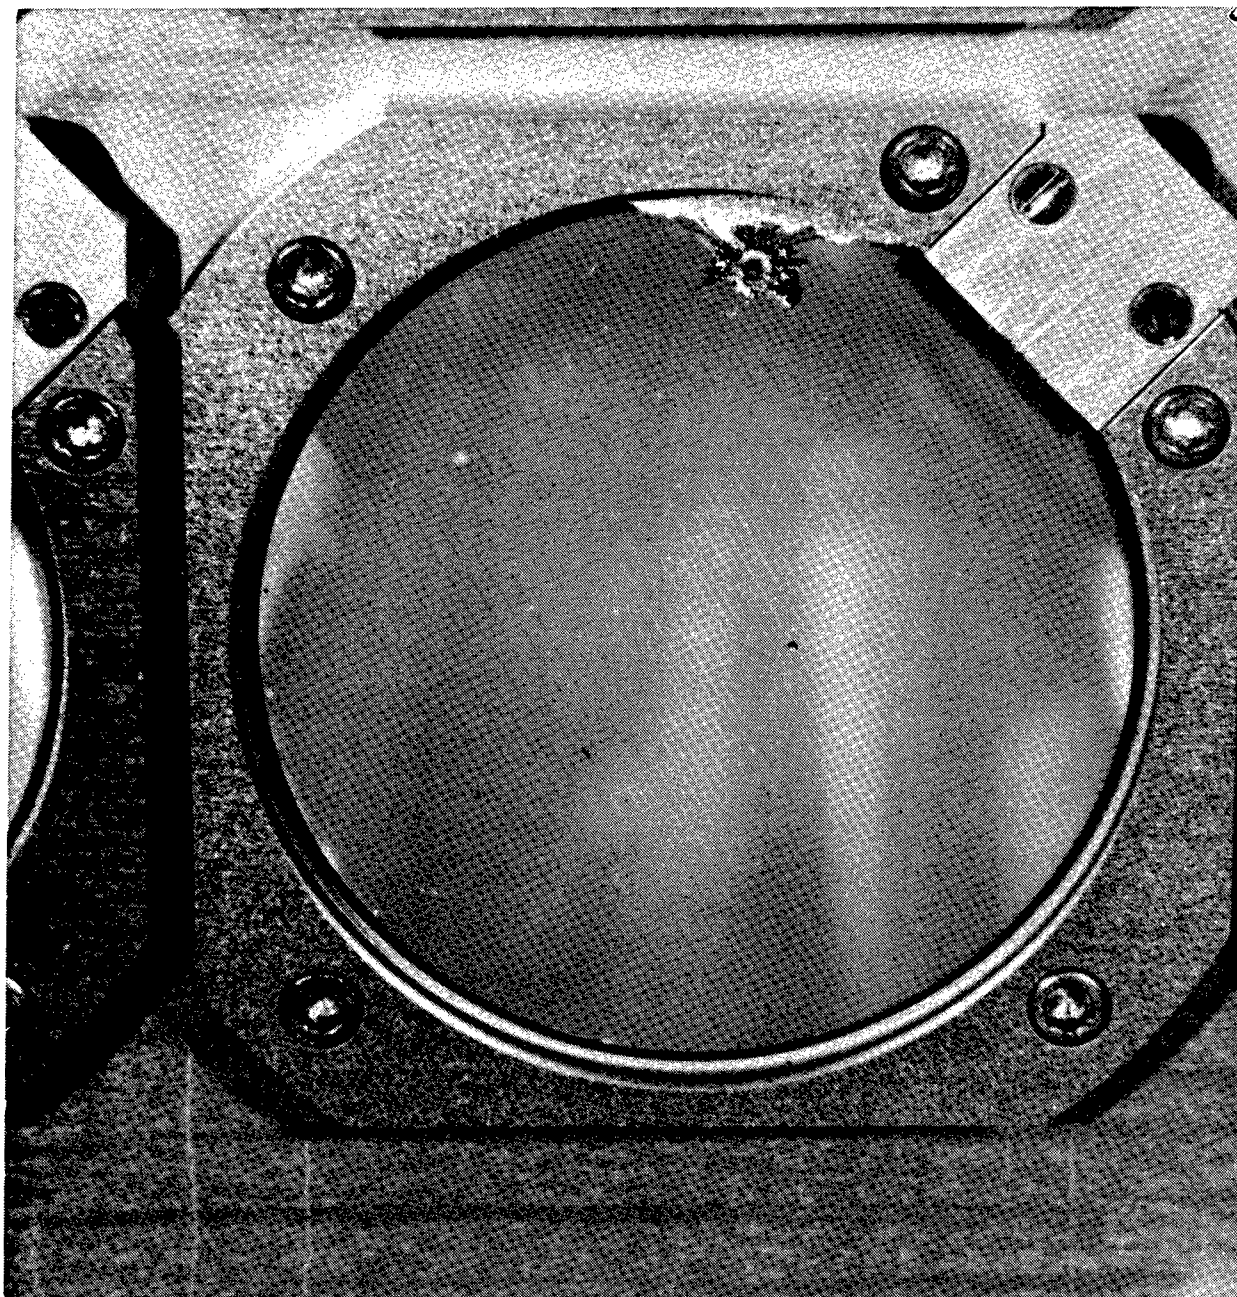
Figure B12-2. This is a view of impact feature #17, with associated shattering, onto a MOS detector. View measures approximately 9 cm across.

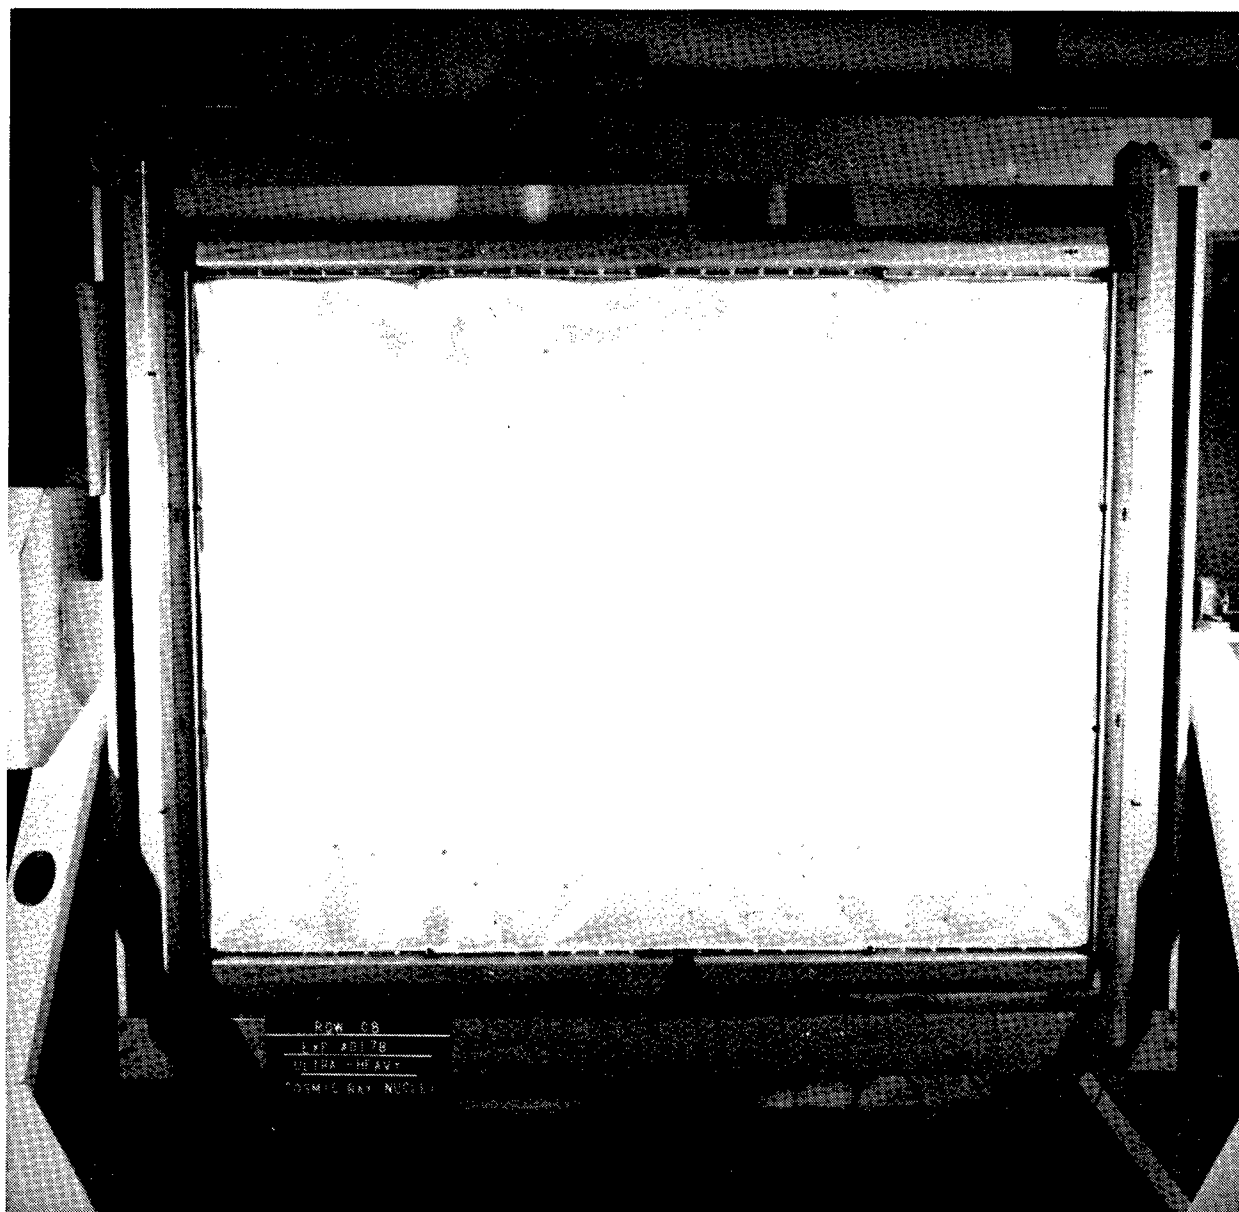
Figure C08-1. This post-deintegration view shows the front of the entire C08 experiment thermal blanket. Oxygen erosion has given this blanket a frosted appearance. The large impact (#94, with a streak) on the lower right is shown in Figure C08.

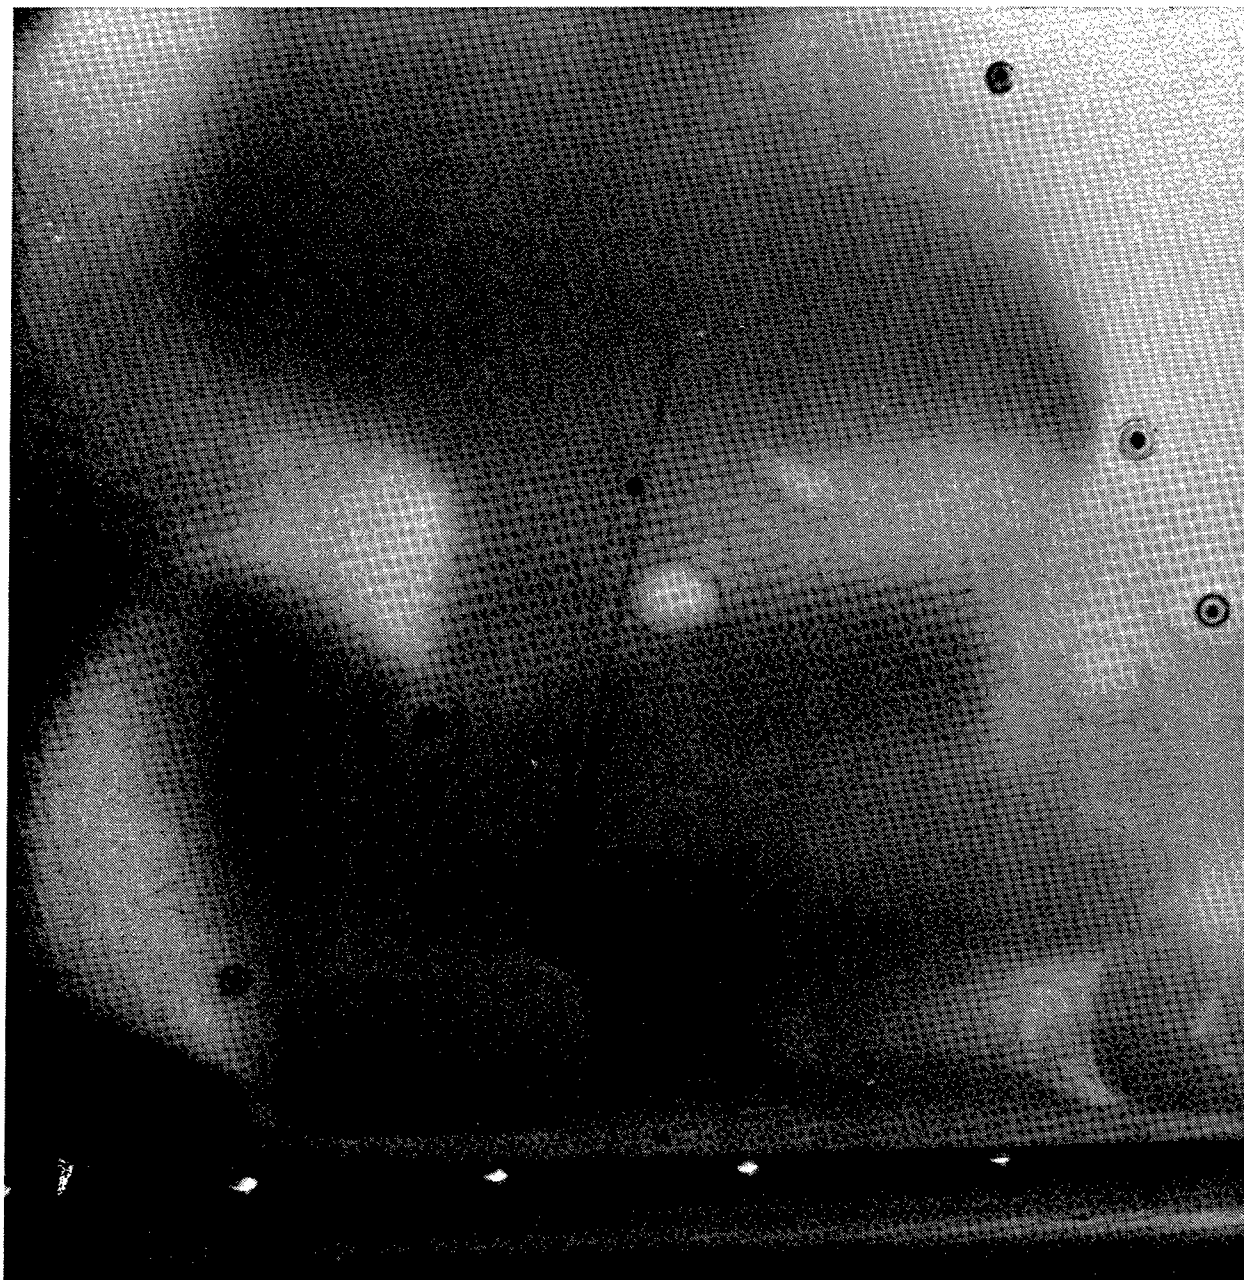
Figure C08-2. This view shows several impact penetrations on C08, most with rings and delamination areas. A large streak of impact-related origin accompanies feature #94. View measures approximately 21 cm across.

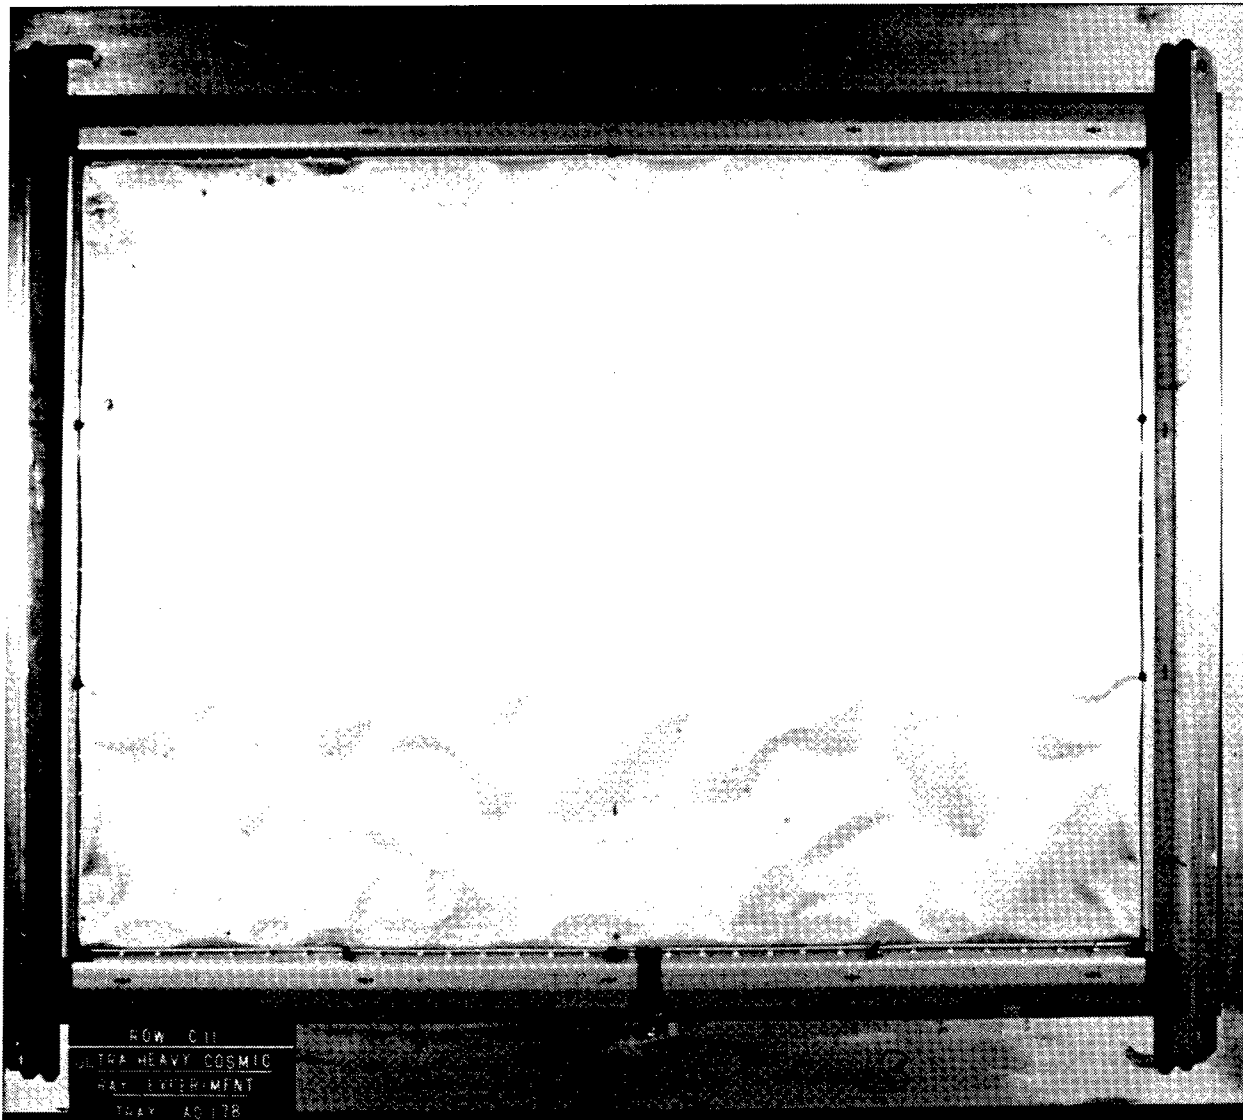
Figure C11-1. This post-deintegration view shows the front of the entire C11 experiment thermal blanket. Oxygen erosion has given the blanket a frosted appearance. The double impact feature in the center of the blanket is shown in Figure C11.

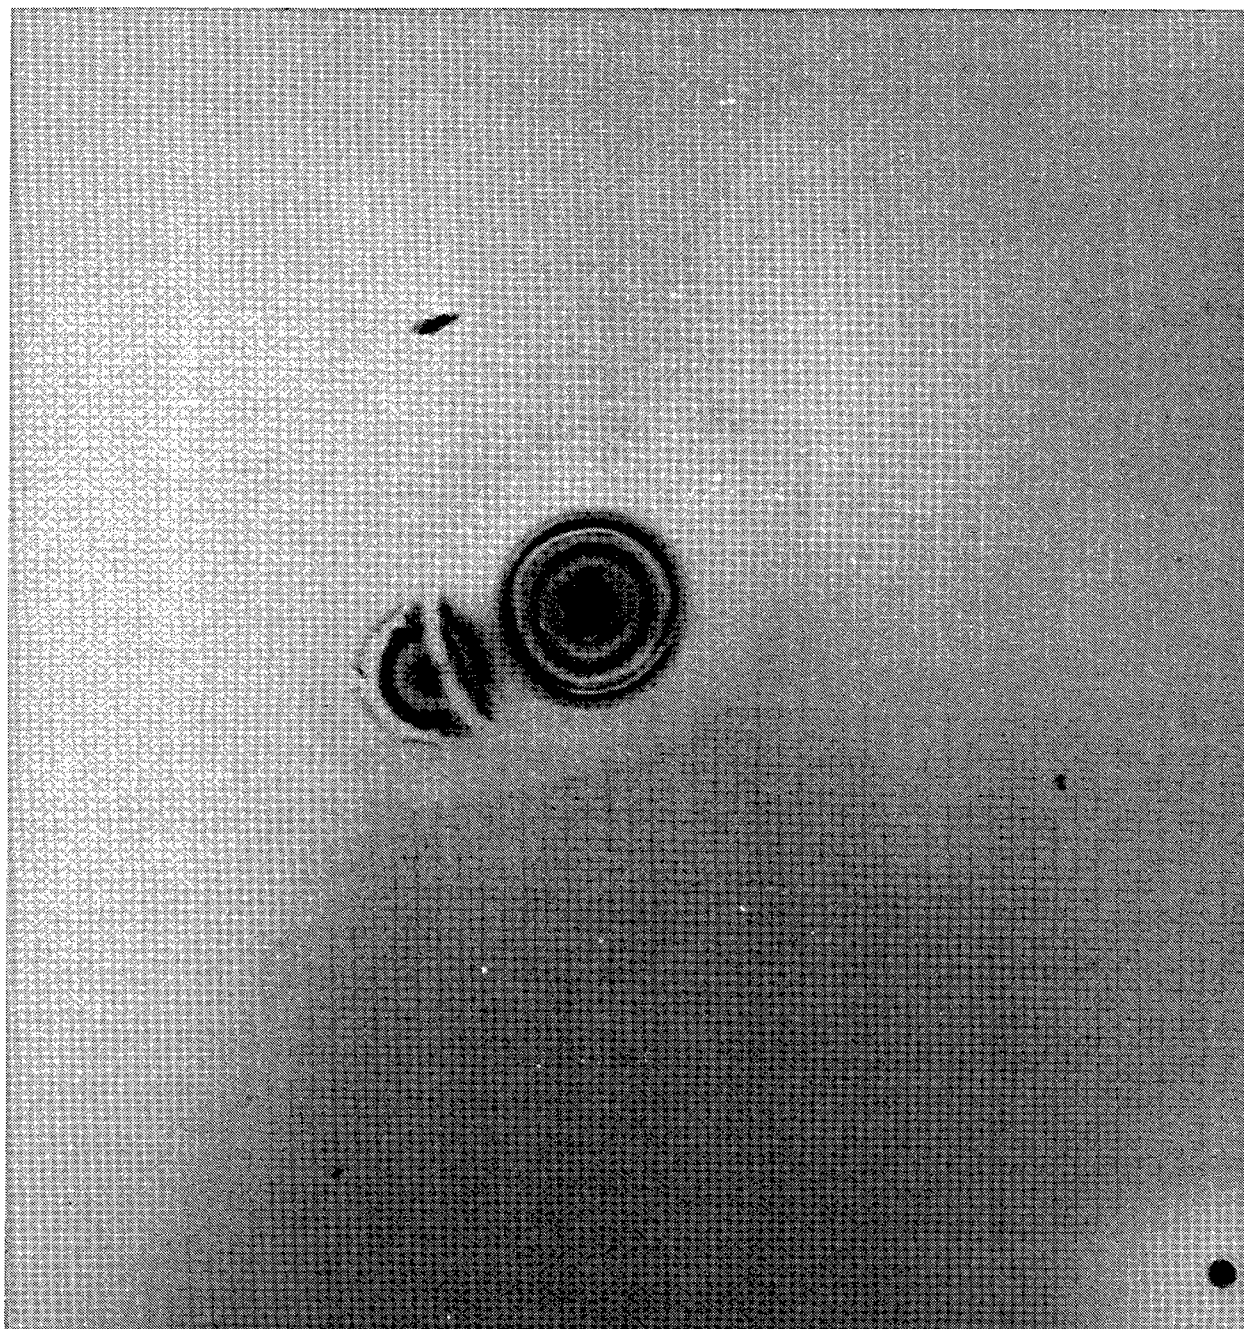
Figure C11-2. This is a pair of impact penetration features on the C11 thermal blanket, both with concentric rings. The rings of the smaller feature are incomplete, possibly related to the formation of the larger impact feature. View measures approximately 9 cm across.

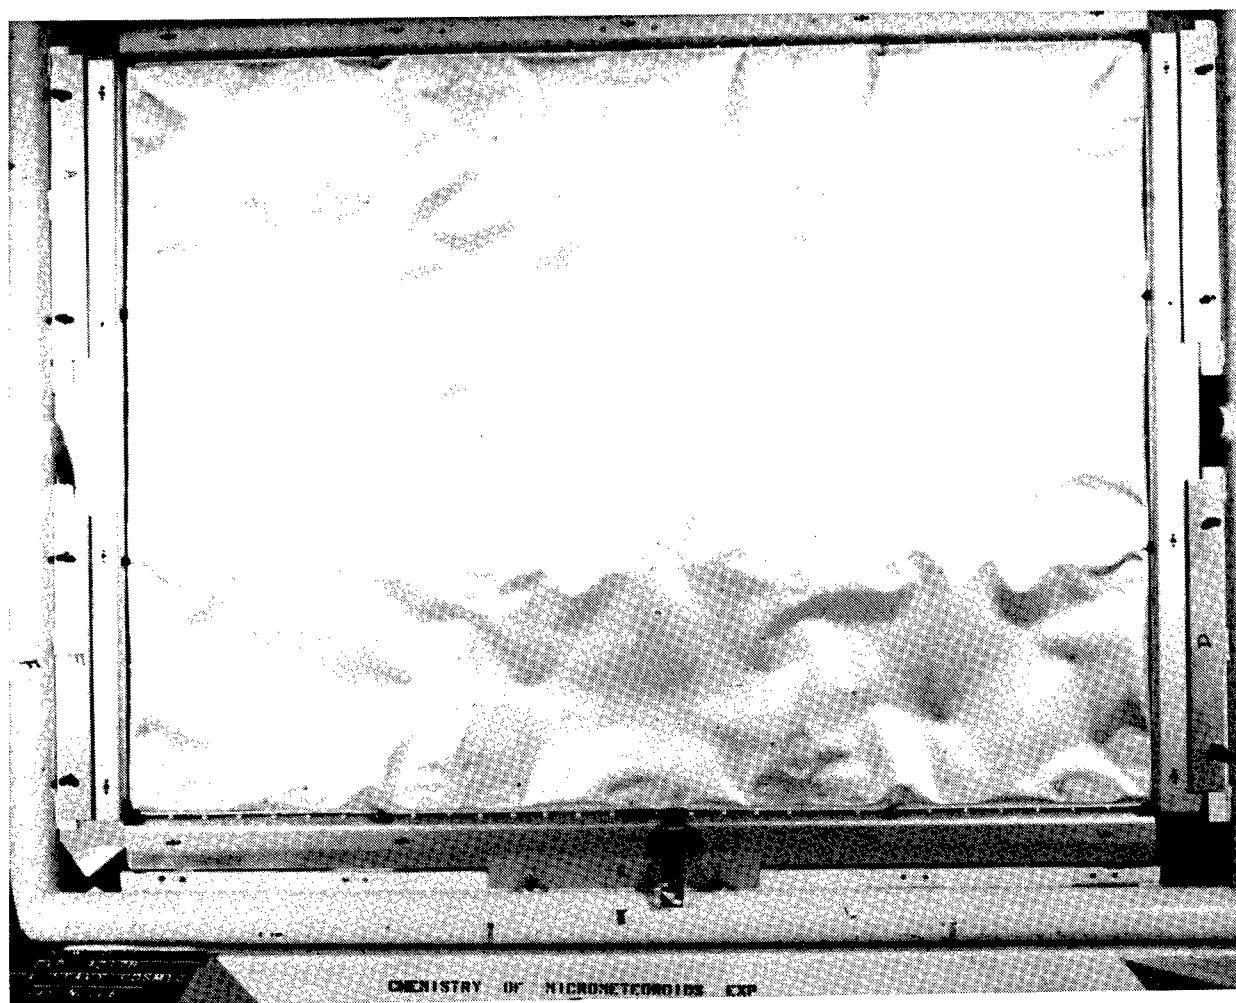
Figure D11-1. This post-deintegration view shows the front of the entire D11 experiment thermal blanket. Some impact features are apparent.

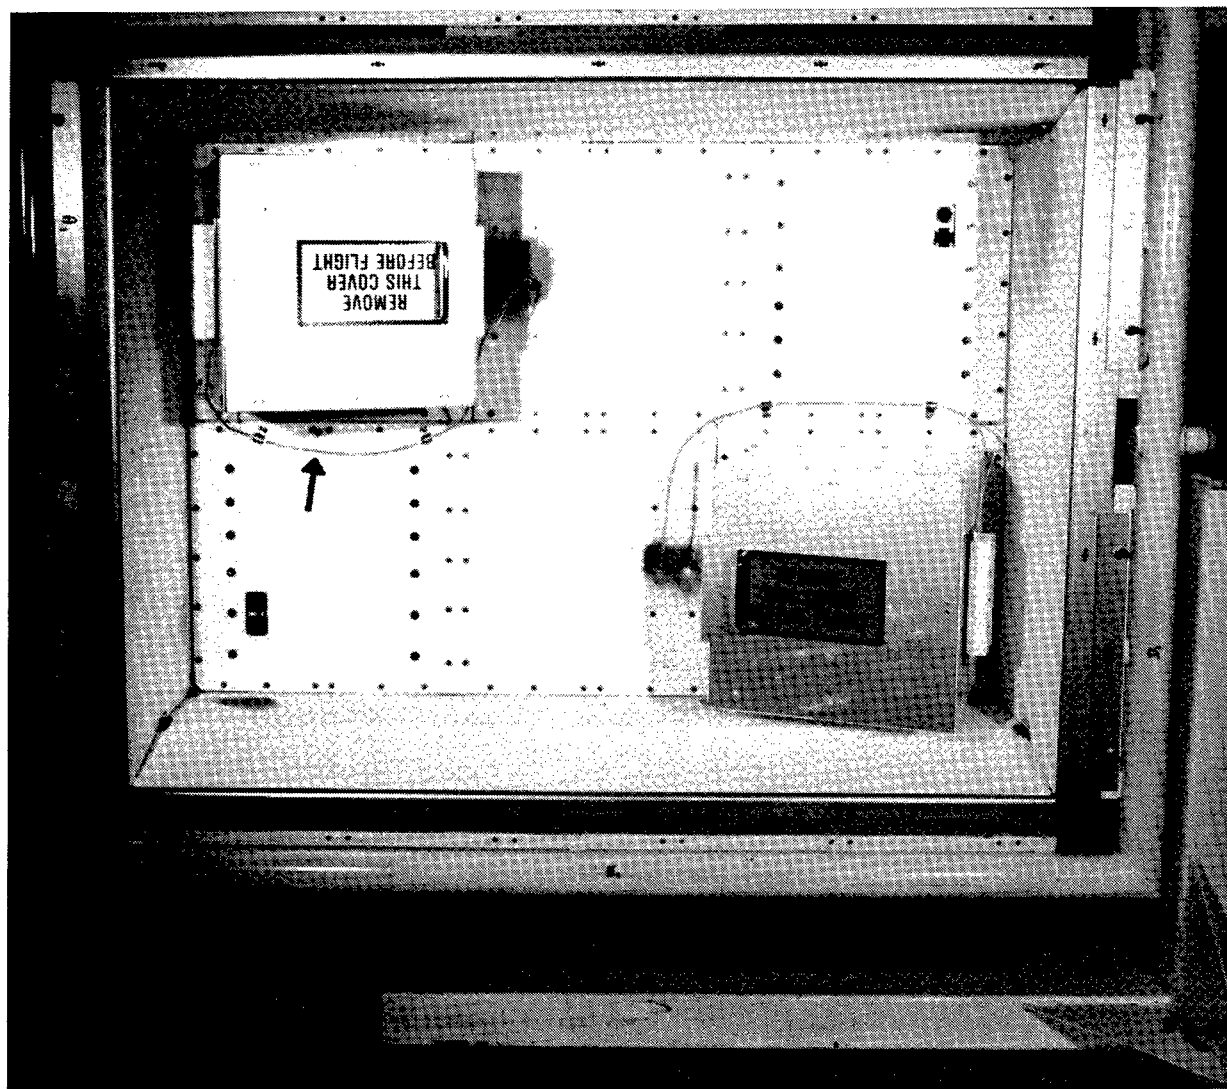
Figure E12-1. This post-deintegration view shows the front of the entire E12 experiment tray. The space-exposed interstellar gas collector foils have been covered in this view. An arrow points to the impact feature (#8) shown in Figure E12-2.

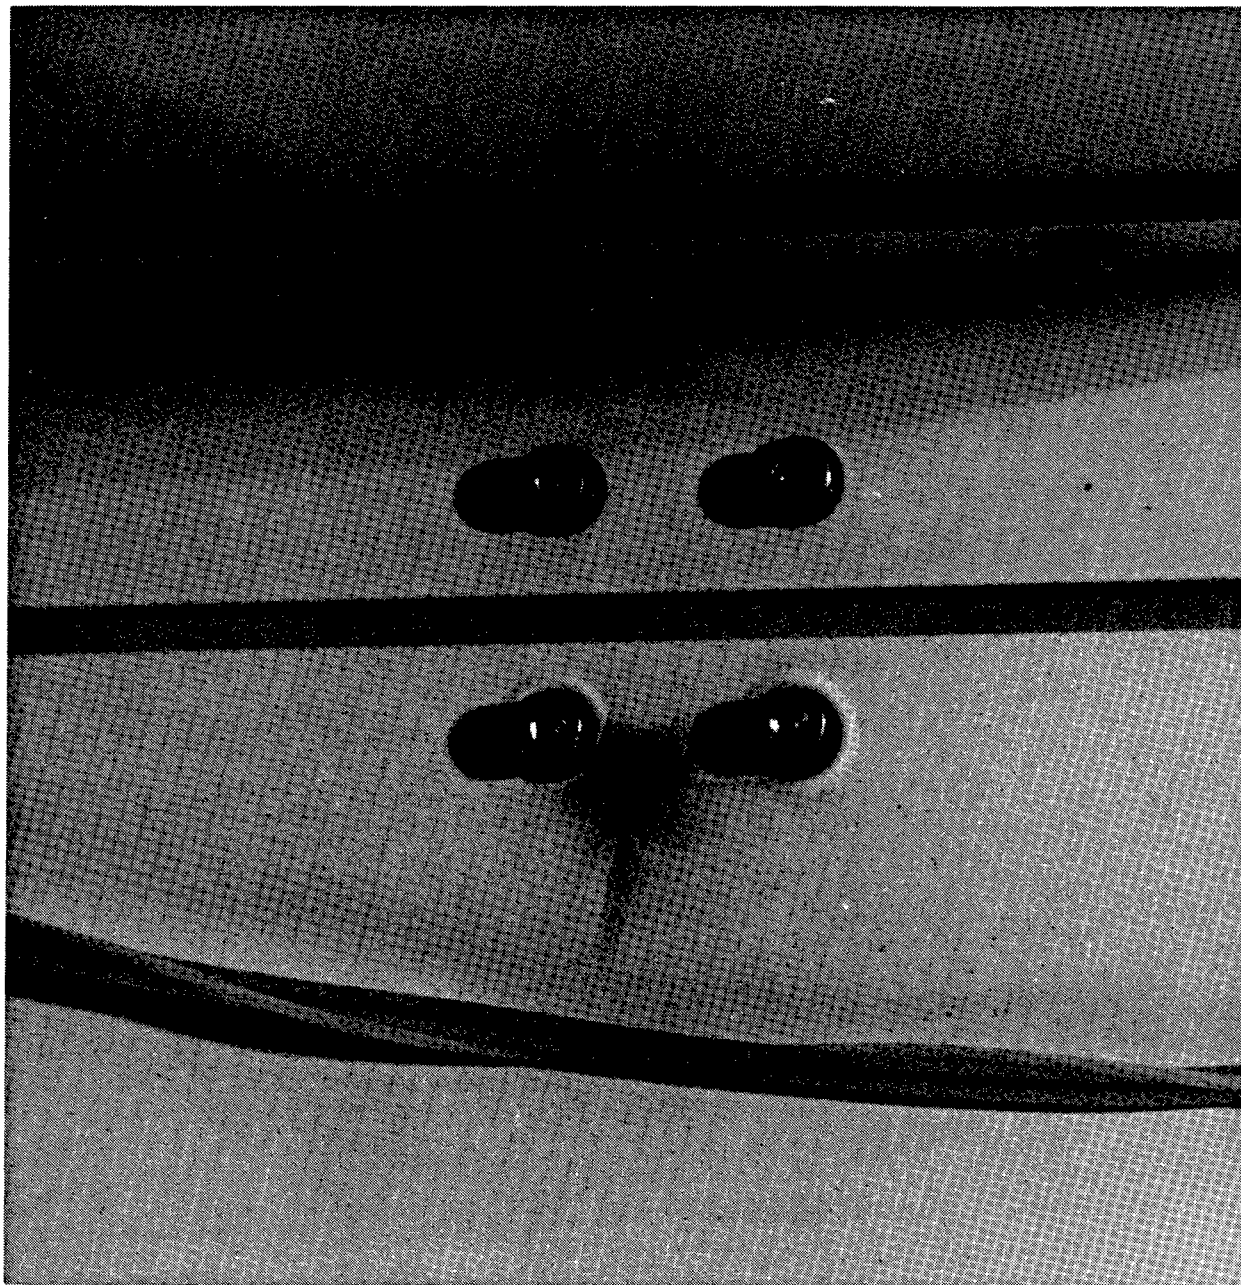
Figure E12-2. This view shows an ejecta spall pattern resulting from an impact (#8) into the lower left bolt head. View measures approximately 11 cm across.

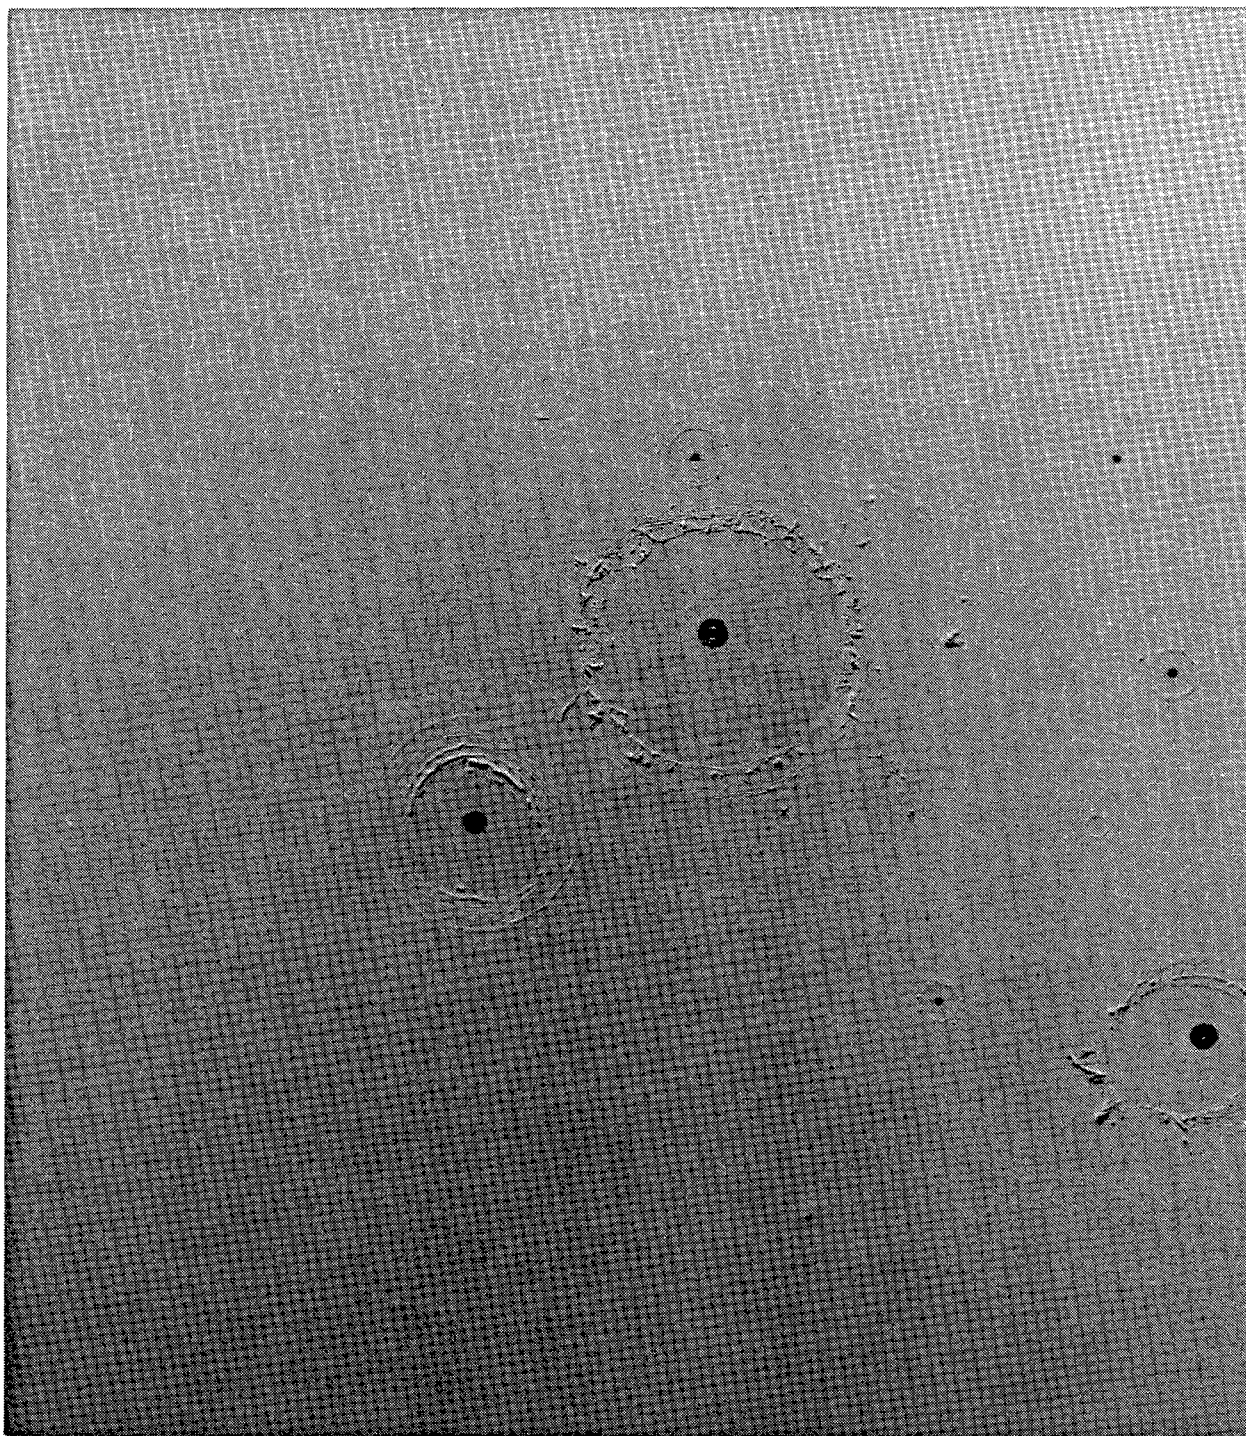
Figure F08-2. Impact features into the white-painted aluminum surface. Each crater extends through the paint into the aluminum substrate. Paint delamination features surround each impact. View measures approximately 8 cm across.

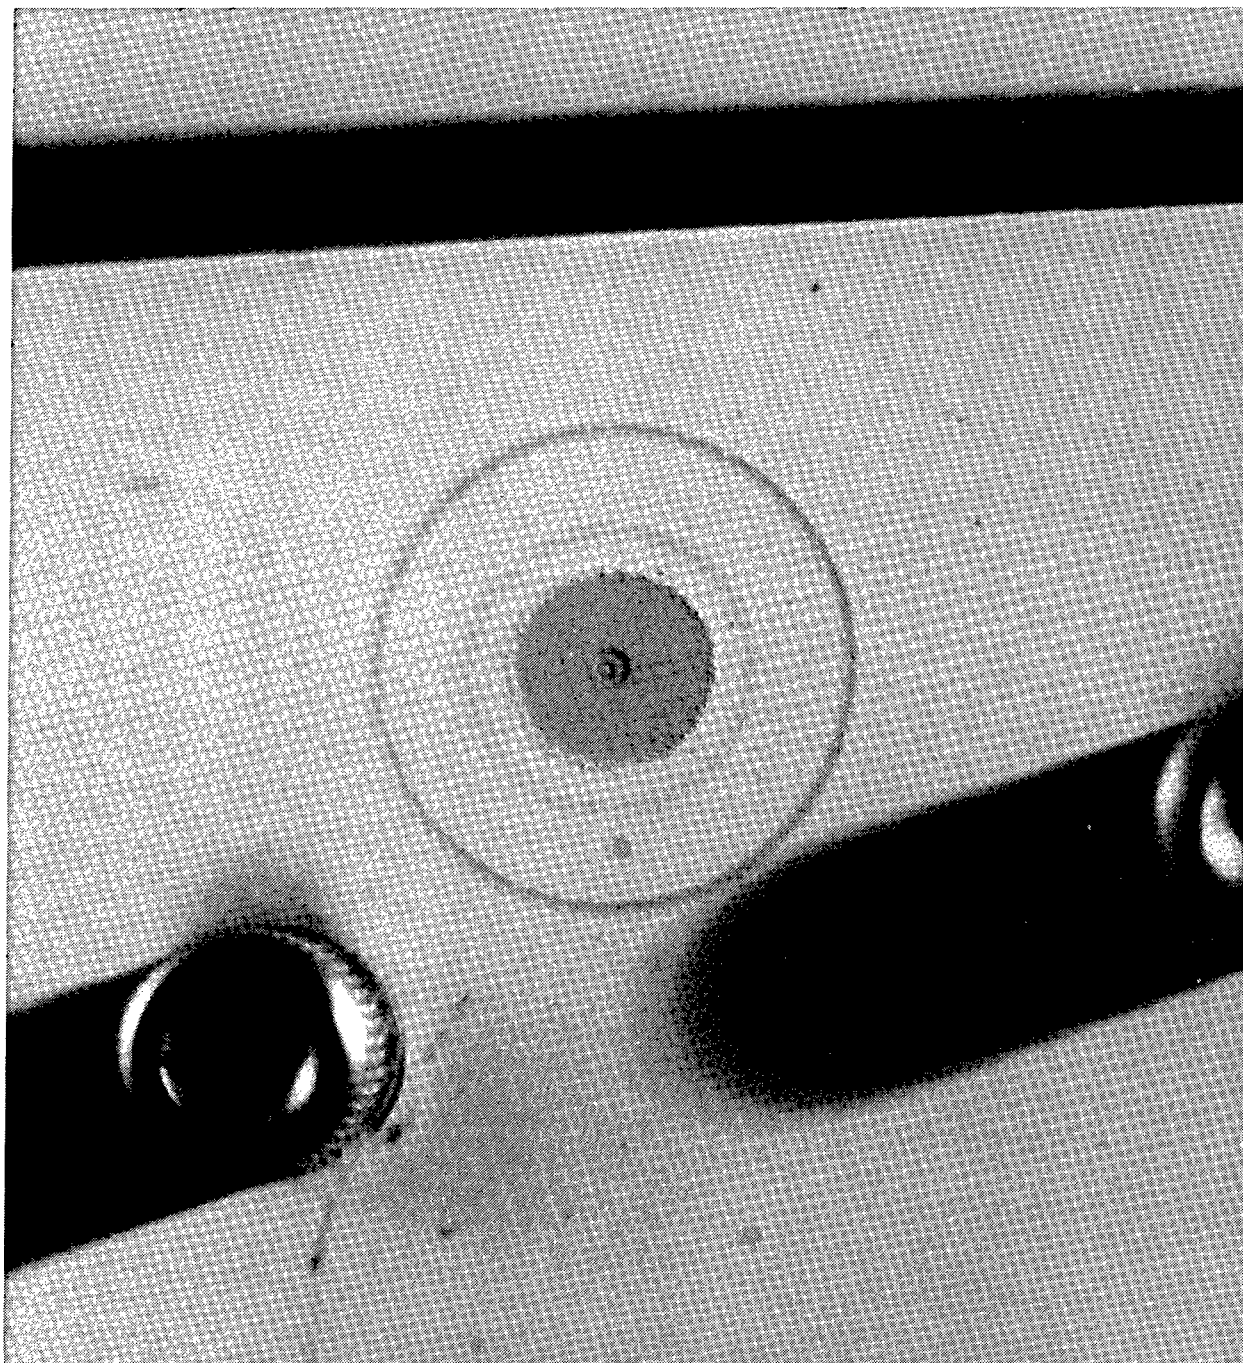
Figure F08-3. A concentrically-ringed impact feature into the white-painted aluminum surface. View measures approximately 4 cm across.

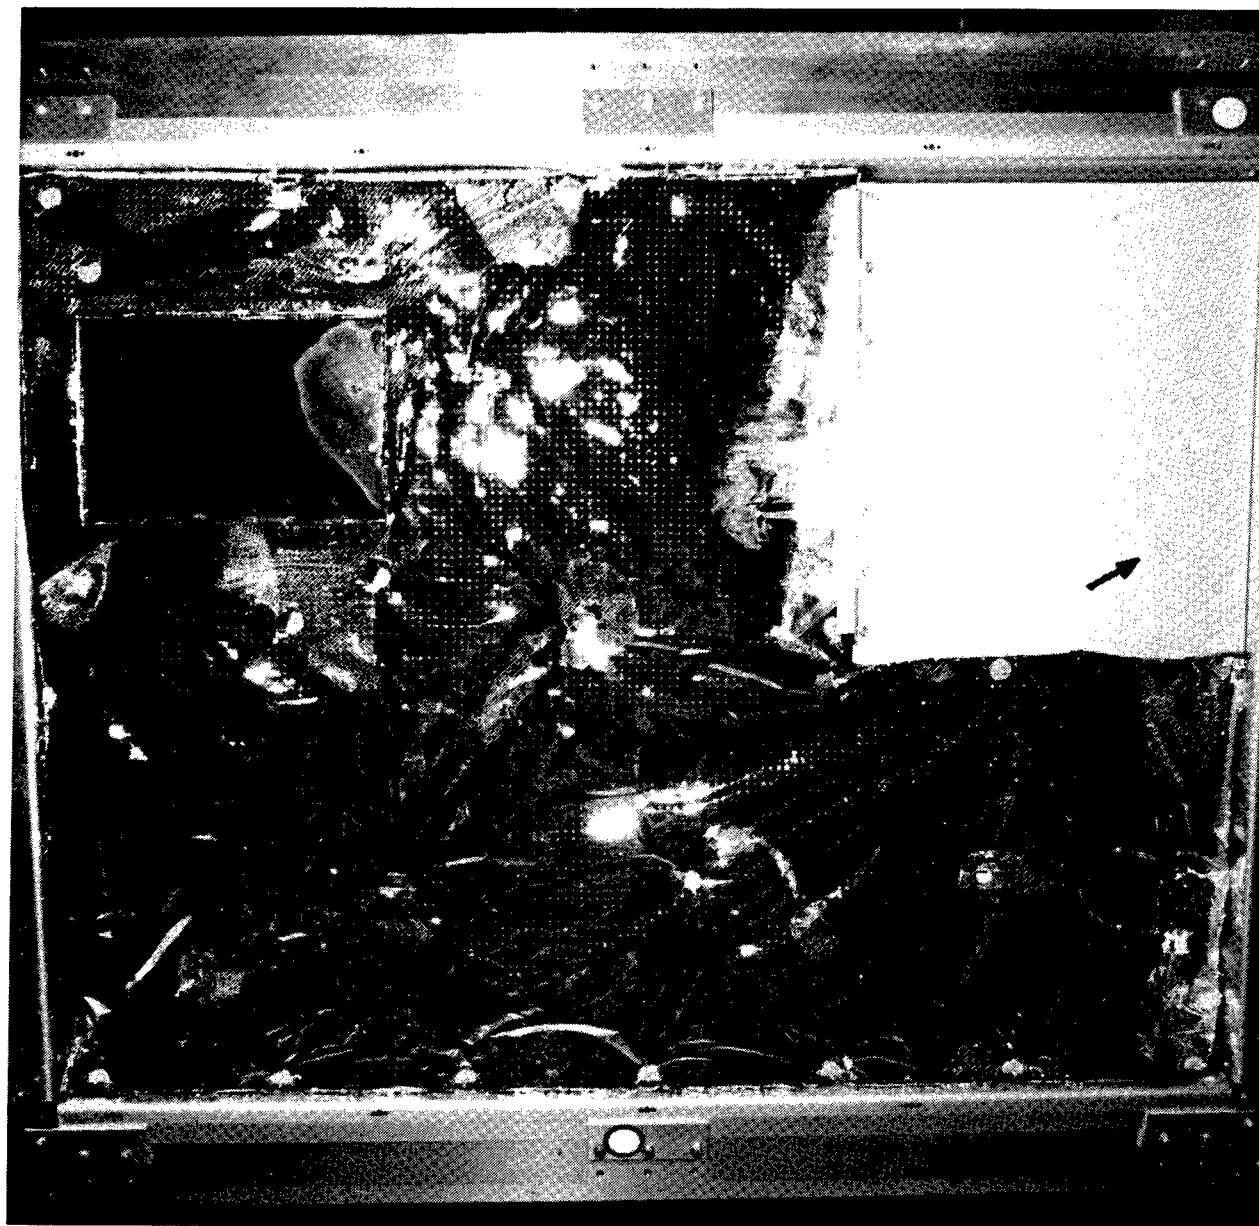
Figure F09-1. This pre-deintegration view shows the front of the entire F09 experiment tray, largely showing only the thermal blanket which remained once loosely-adhering foil samples had been removed. A arrow indicates the impact feature shown in Figure F09-2.

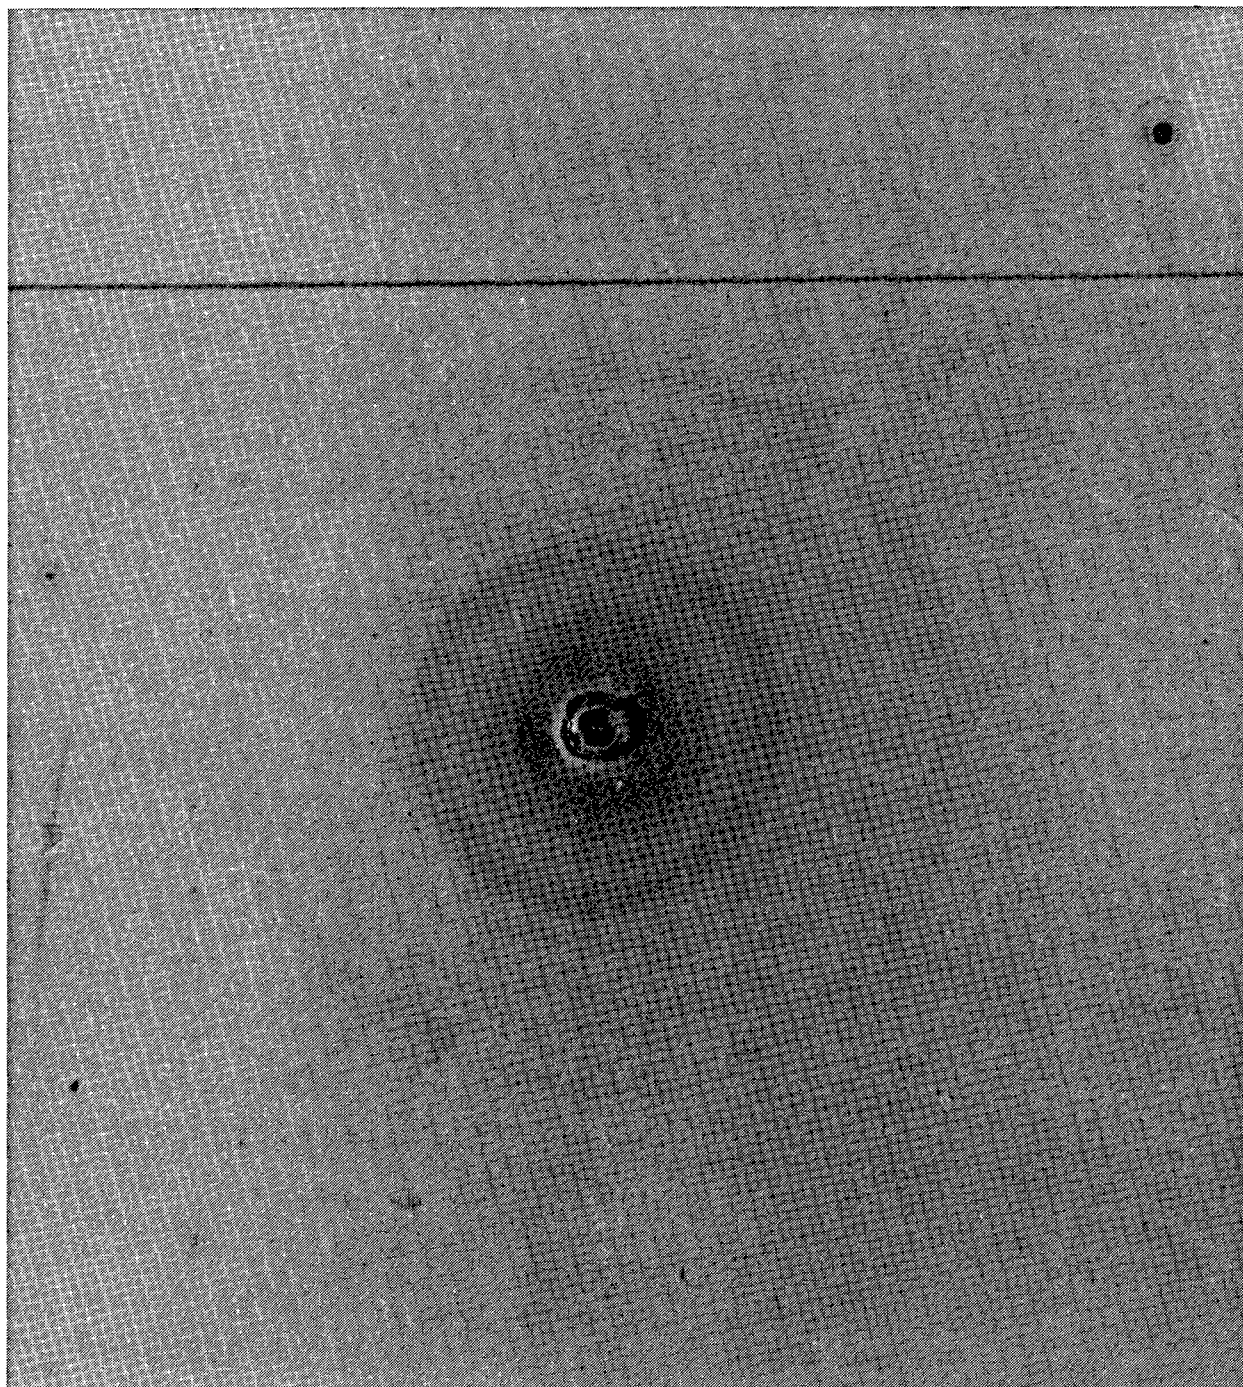
Figure F09-2. A concentrically-ringed impact feature into the white-painted aluminum surface. View measures approximately 8 cm across.
